Use and Application of Inflatable Dam Seals in Large Concrete Dams

Guy Dickes: Constellation Group LLC, 6718 Chokeberry Road, Baltimore, MD 21209 USA

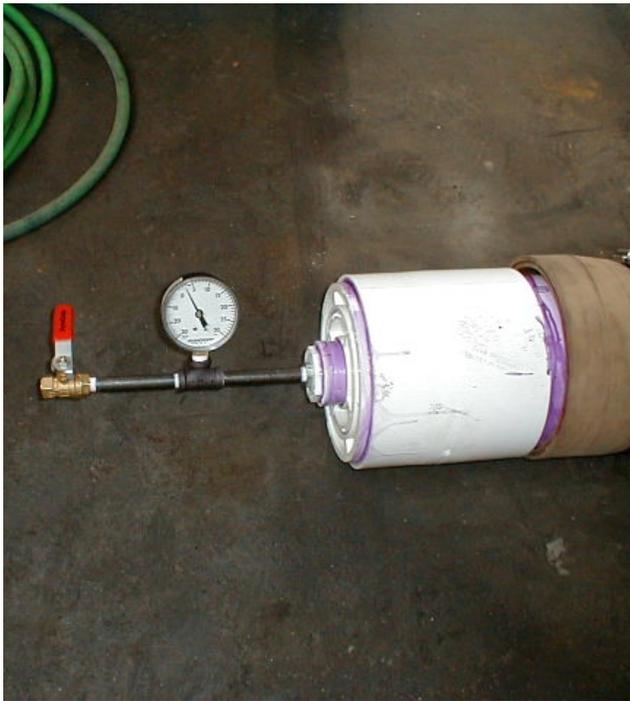
Figure 1: Air Testing - Day 3
GeoStructural Facility, Baltimore, Maryland

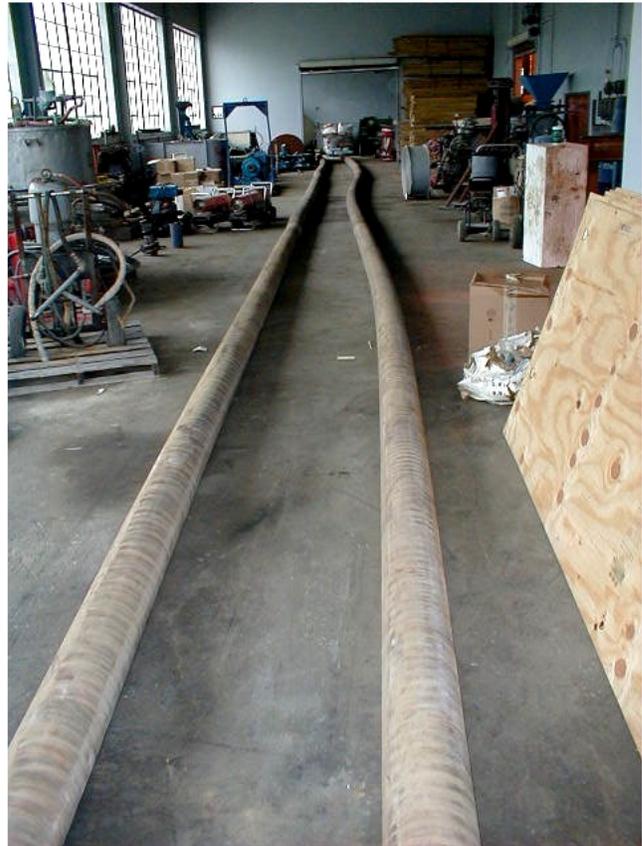
Figure 2: Seals Laid Out and Pressurized
GeoStructural Facility, Baltimore, MD

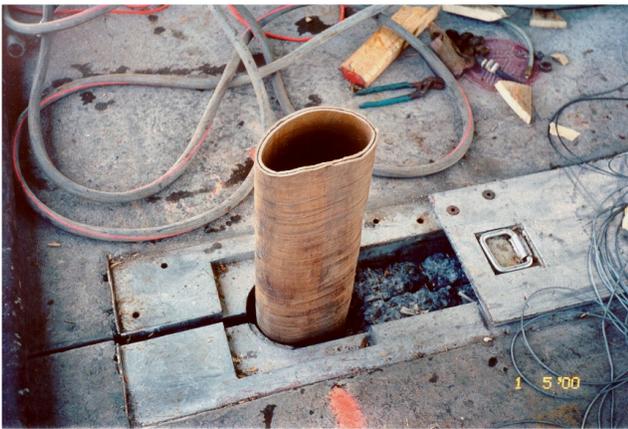
Figure 6: Seal Installed
Chickamauga, Tennessee

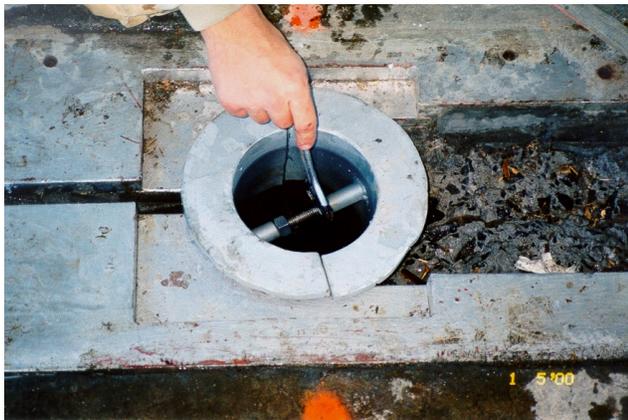
Figure 7: Capture Ring Being Fitted
Note Sawcut and Condition of Concrete
Chickamauga, Tennessee
