## **Use and Application of Inflatable Dam Seals in Large Concrete Dams**

Guy Dickes: Constellation Group LLC, 6718 Chokeberry Road, Baltimore, MD 21209 USA  
[www.cgllc.us](http://www.cgllc.us)

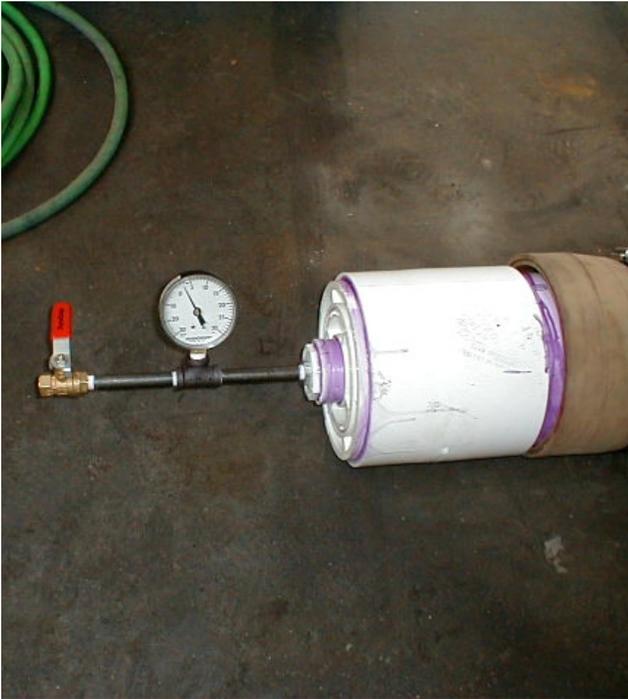
Figure 1: Air Testing - Day 3  
GeoStructural Facility, Baltimore, Maryland

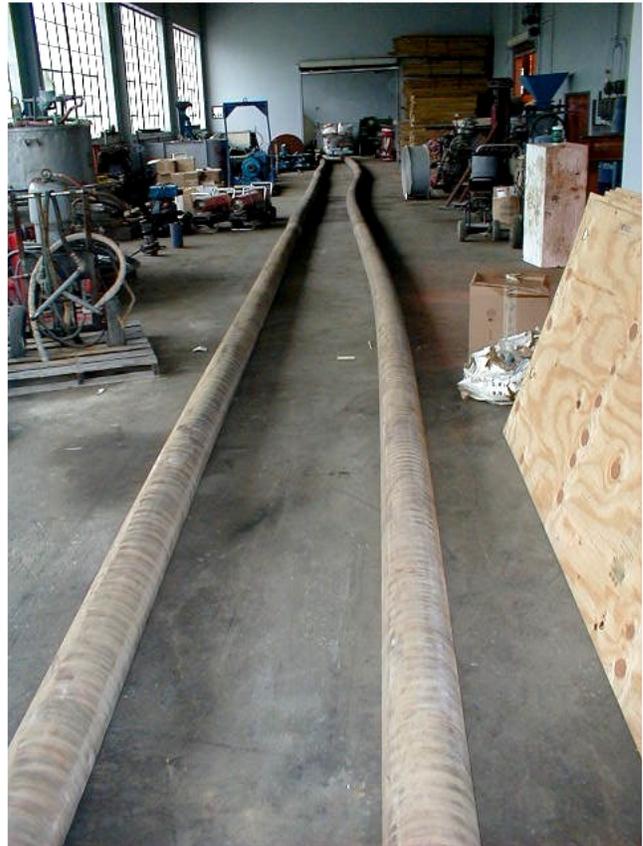
Figure 2: Seals Laid Out and Pressurized  
GeoStructural Facility, Baltimore, MD

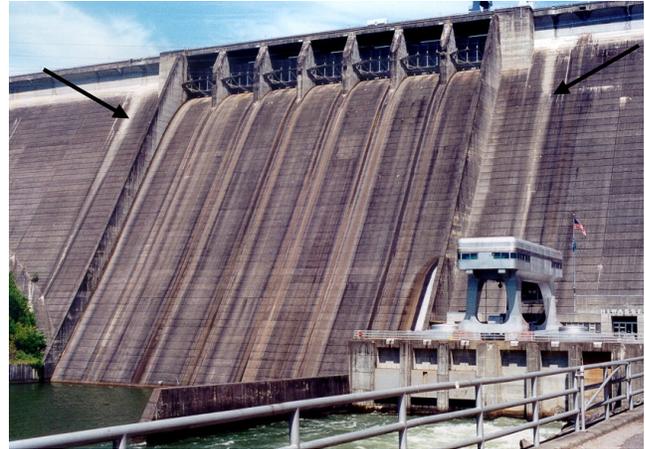
The Hiwassee seals were first installed in 1995, subsequently removed for additional sawcutting and new seals installed in 1999. As the alkali aggregate reaction continued, it was necessary to sawcut the dam upper spillway and redrill the boreholes.

Figure 3: Two Sawcuts, Either Side of Main Spillway, Prior to Seal Installation Hiwassee Dam, Tennessee

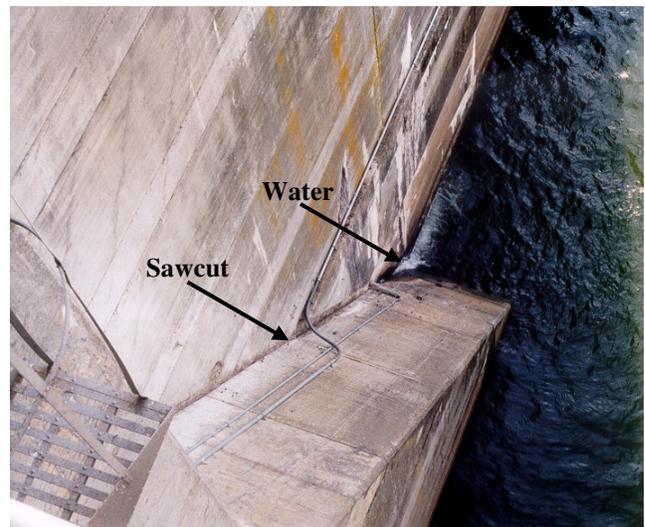
At Chickamauga Dam, one 8-inch diameter, 125-foot long seal was installed in 1999. Again, this was as a result of alkali aggregate reaction problems. The challenge at this dam was installing the seal under 80 feet of flowing water through the sawcut (Figures 4,5, 6, 7).

Figure 4: Water Flowing Through Sawcut Chickamauga Dam, Tennessee

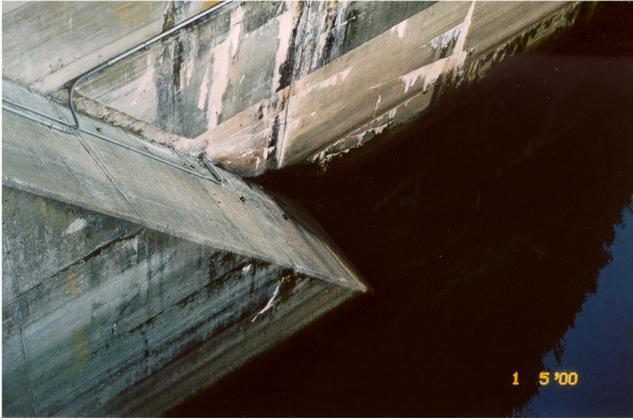
Figure 5: Immediately After Dam Seal Inflated  
Chickamauga, Tennessee

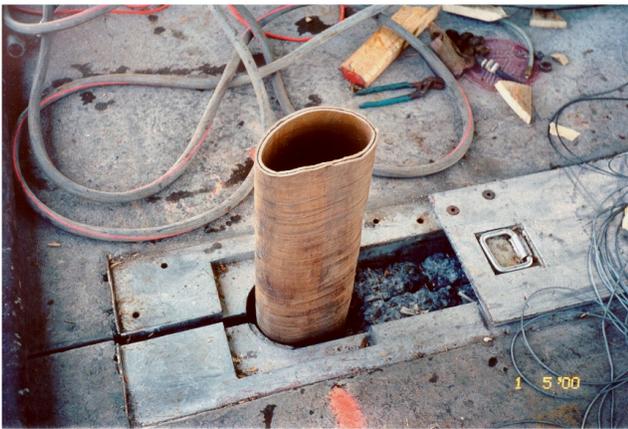
Figure 6: Seal Installed  
Chickamauga, Tennessee

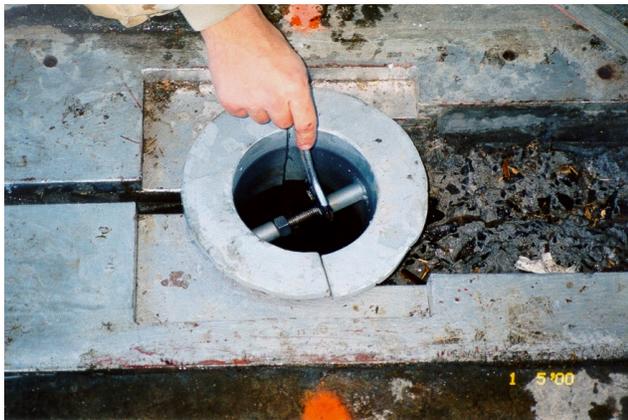
Figure 7: Capture Ring Being Fitted  
Note Sawcut and Condition of Concrete  
Chickamauga, Tennessee

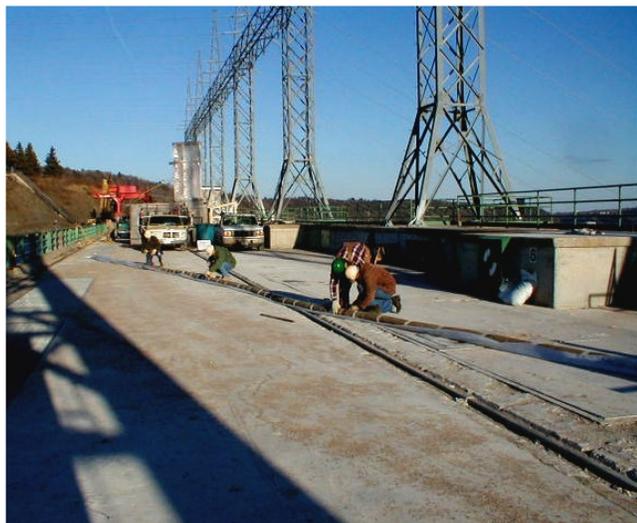
Figure 8: Preparing the Seal for Installation  
Mactaquac Generating Station  
Keswick Ridge, Canada

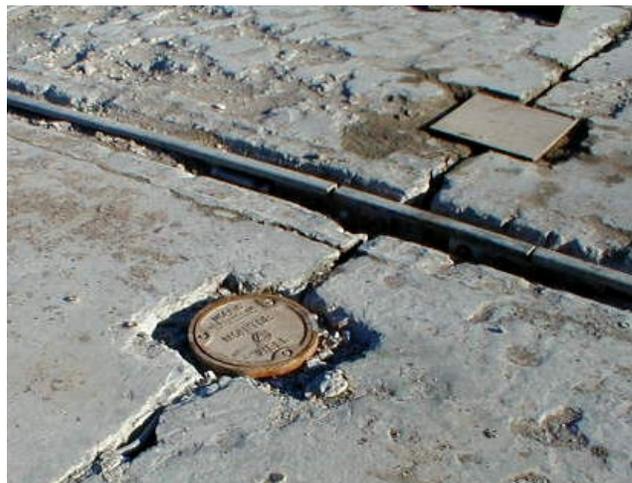
Unique to Mactaquac Dam was the requirement for two inline seals within one transverse sawcut (Figure 9). Of utmost importance was duplicity in seal integrity and not allowing any water to pass to the downstream face of the dam. This was accomplished by sawcutting only halfway through the dam at a time. The first dam seal was installed in Summer 2000 on the upstream portion of the dam. The sawcut was completed and the second seal was installed in December 2000 (Figures 8, 10, 11).

Figure 9: First Seal Installed  
Plywood Plate Covering Second Borehole  
Mactaquac Generating Station

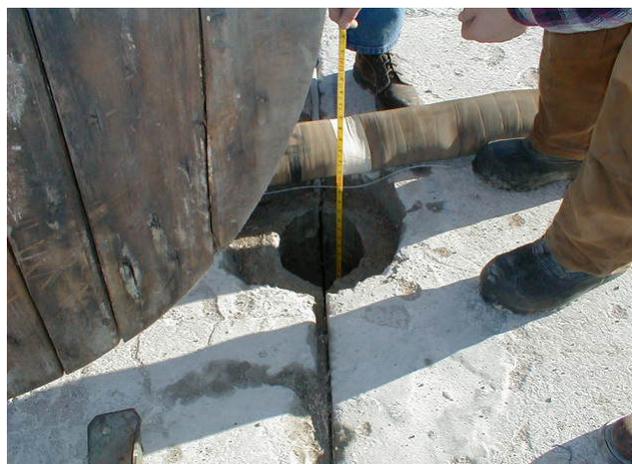
Figure 10: Measuring the Depth of the Borehole Is  
Critical to a Successful Dam Seal Installation  
Mactaquac Generating Station

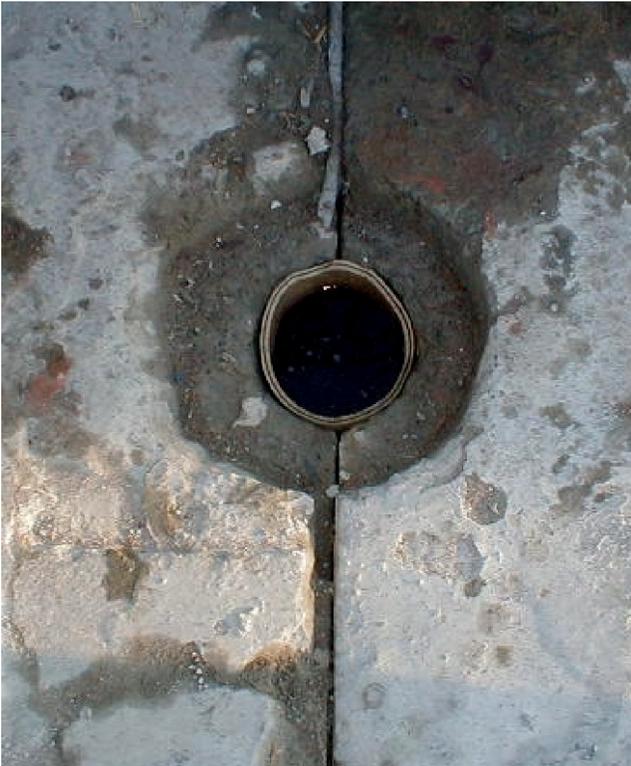
Figure 11: Second Seal Installed and Inflated  
Mactaquac Generating Station
