Nashville, TN  
March 11-15, 2012

Paper F-2-03

## SUPPORT OF TUNNELING WITH CHEMICAL GROUTING IN NEW JERSEY

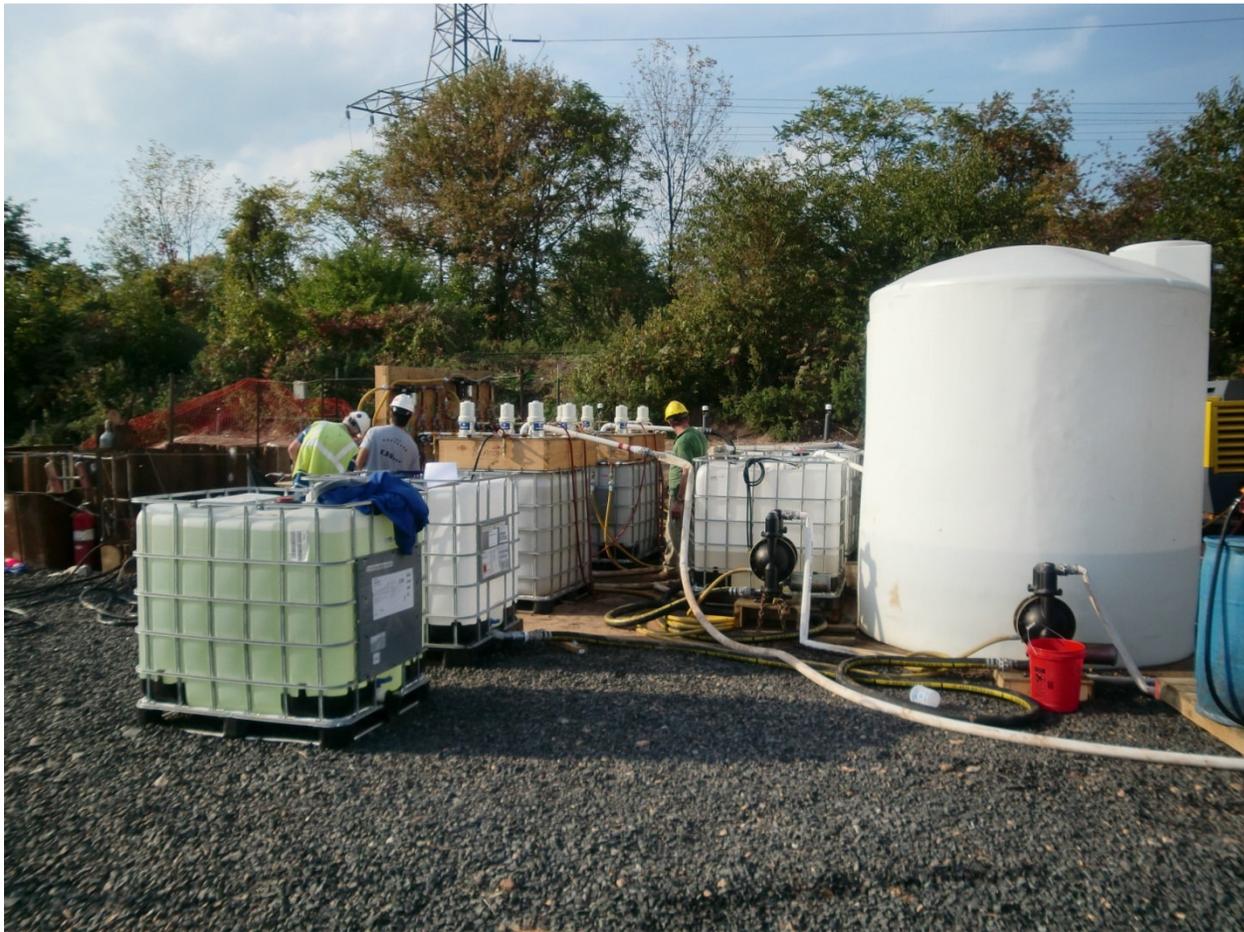
Sodium silicate was delivered to site via tanker truck and stored in large 3,200 gallon polyethylene tanks. The reactant and calcium chloride was delivered in 275 gallon chemical totes. Both the reactant totes and the large sodium silicate poly tanks were plumbed into their respective mixing tanks. A water truck was used for the final component. Calcium chloride was added manually. After the respective materials were mixed, they were transferred into pumping tanks, and thereafter pumped by their respective A and B pumps. Pumps and hoses were colored coded for identification. Figure 4 shows the grout plant.

**Figure 4.** The Grout Plant

Sodium silicate grouts are usually pumped through a pair of pumps- Side A being sodium silicate and water; Side B being reactant, water and calcium chloride. These two components are combined prior to the packer. In rare instances and small quantities, all components can be batched and pumped through one pump, but is generally not permitted by specification. In the case of NER/SRVSA the grout plant consisted of four pairs of primary grout pumps, feeding four grout hoses. Each grout hose was terminated with an inflatable dual packer. These packers isolate each port (group of four holes) on the SPP and permit grouting in a specified location. Flow meters and pressure gauges on each line gave volume and pumping pressure for each pair of pumps.

As each A&B component was pumped, they were mixed in a static mixer and then down the grout hose to the SPP. Pressure and volume was measured and recorded on each grout port.

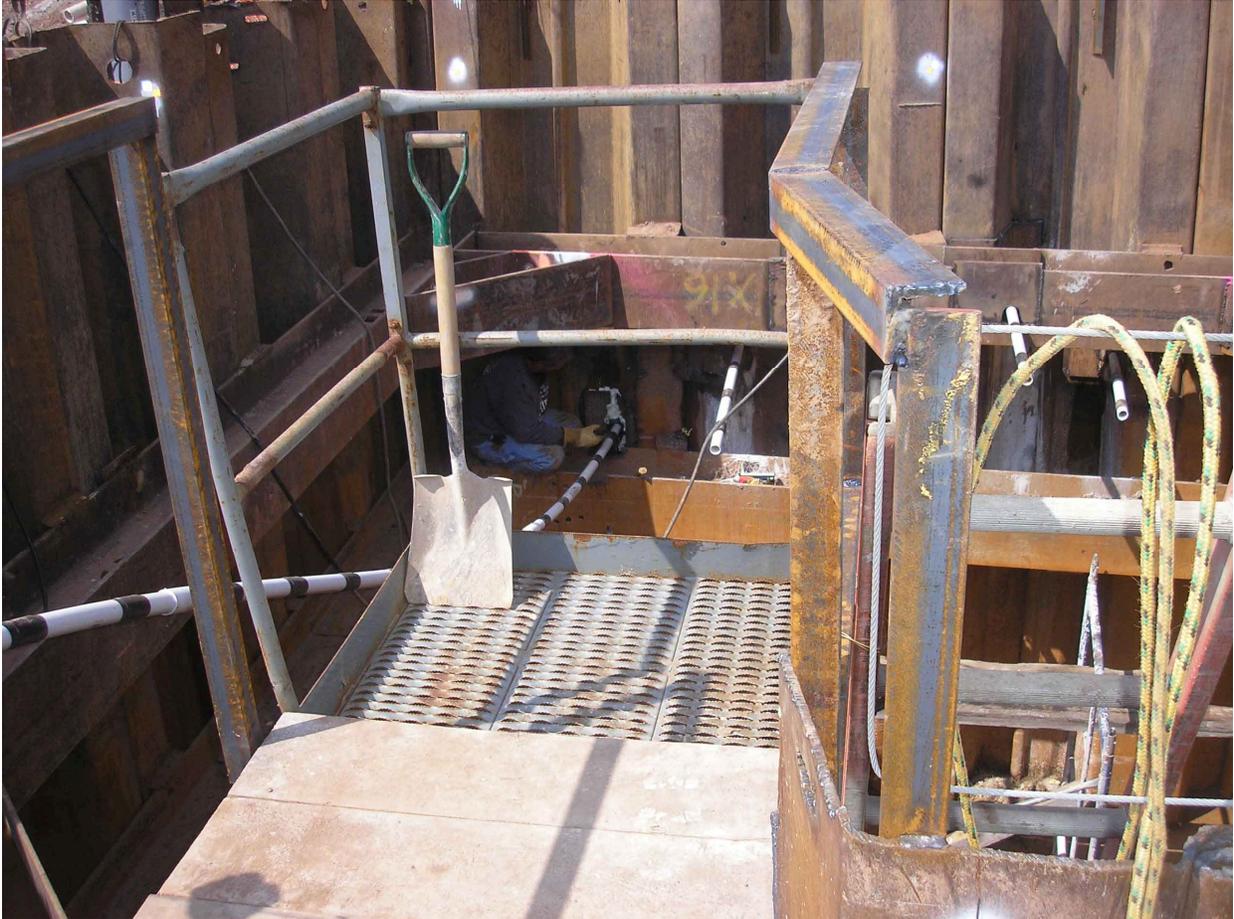
**Figure 5.** Sleeve Port Pipes Going In

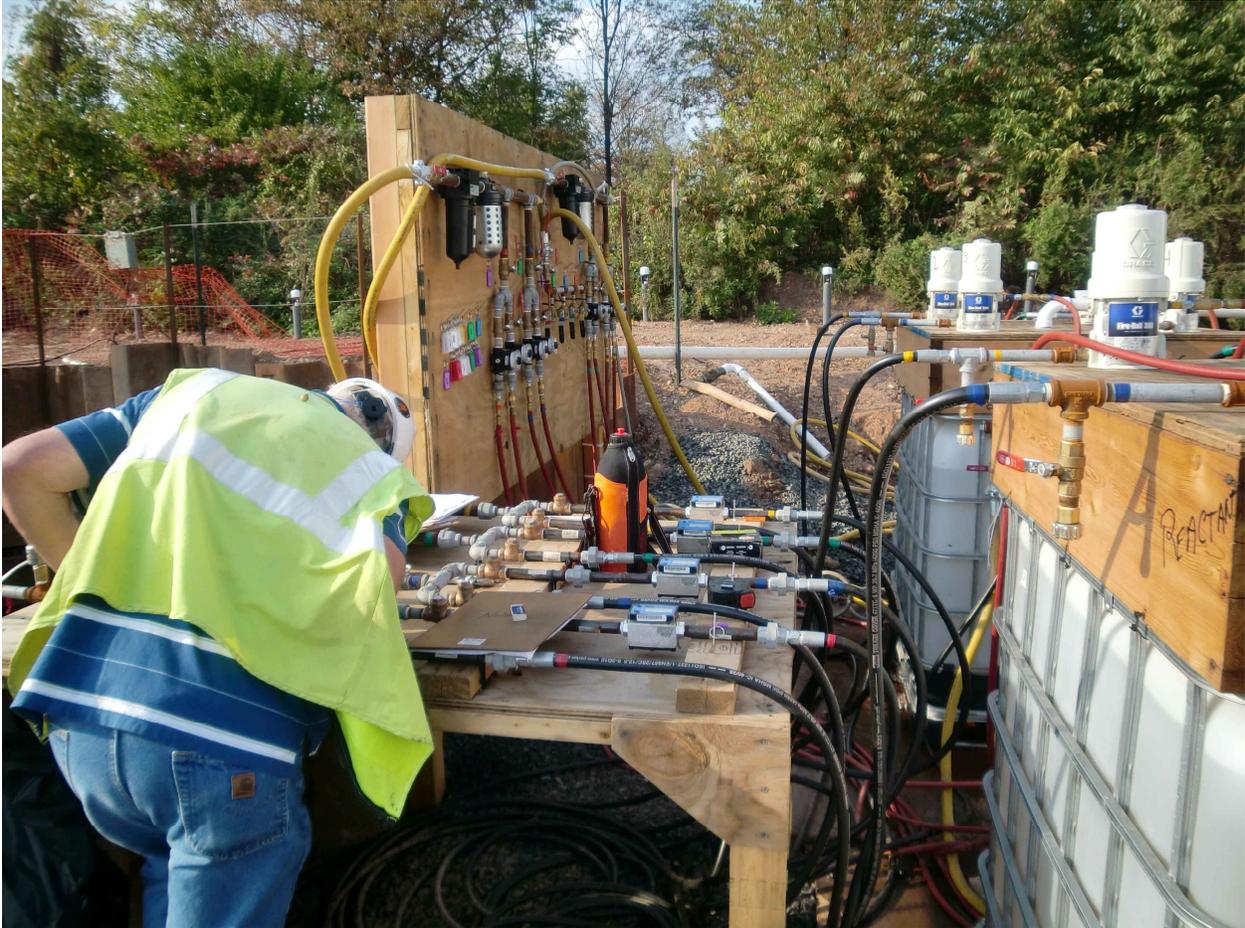
The hoses were not only colored coded, but marked with port numbers as well- see Figure 6. At any given point in time, an individual hose could be indentified and the port being pumped could be determined. This proved important as certain zones required additional grout at later times.

**Figure 6.** Grout Operations  
Note Color Coding for Identification

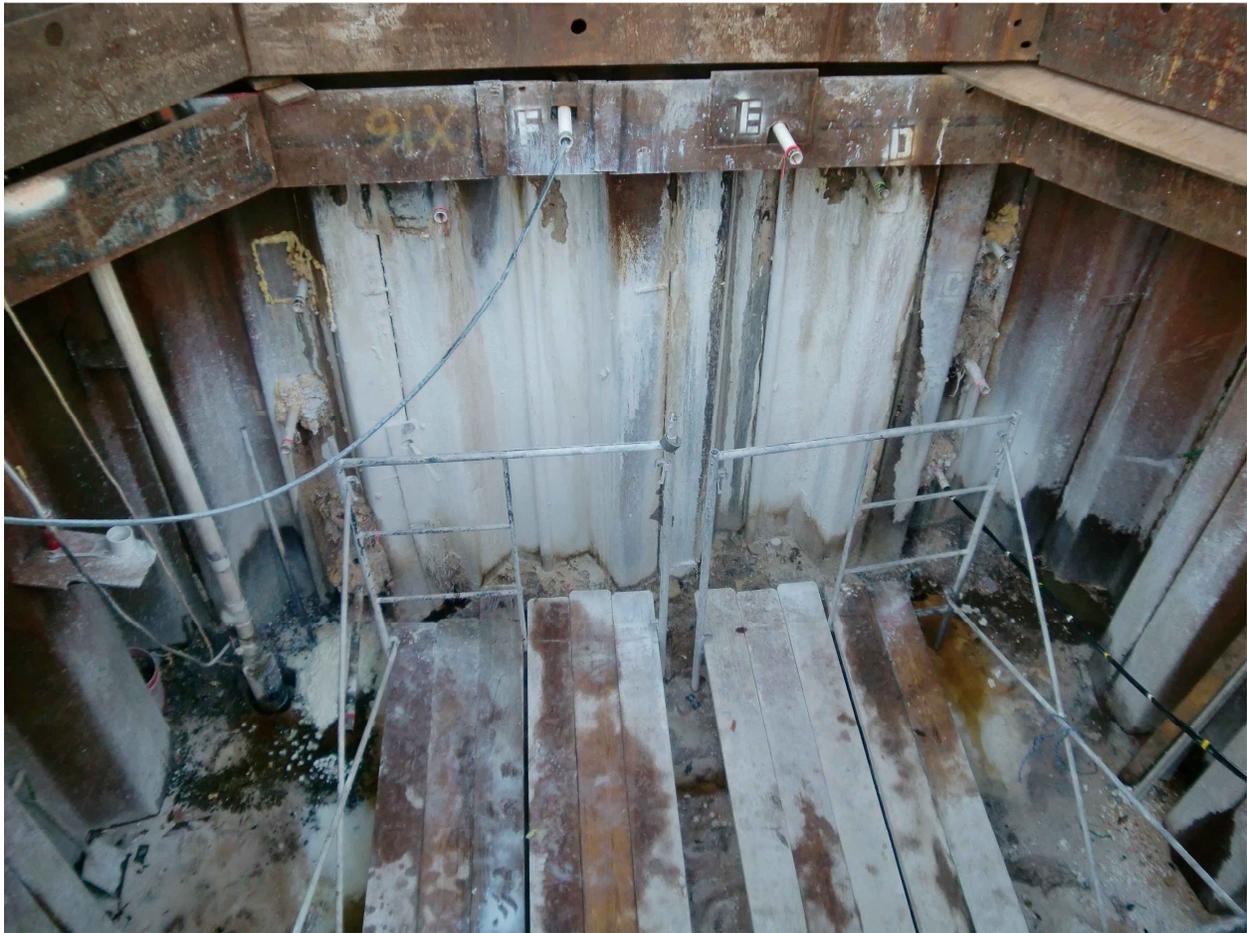
Another noticeable improvement during grouting was the reduction of water in the launch and receiving pits. The daily groundwater discharge volume was monitored. By the time grouting was completed, ground water discharge was down 75-85%. During tunneling operations, ground water encountered in the tunnel bore, a potential serious

**Figure 7.** The Receive Pit is Dried Out
