## **VACUUM GROUTING REPAIRS FOR EXISTING POST-TENSIONED STRUCTURES AND NEW CONSTRUCTION**

**Guy Dickes**, President, Constellation Group LLC

**ABSTRACT:** Vacuum grouting repairs have become a necessity in bridge repair and in new construction of post-tensioned structures. Once only performed by specialty contractors, vacuum grouting can now be performed by a qualified grouting technician employed by the general bridge contractor or precast manufacturer. In new construction, it is occasionally required to perform vacuum grouting repairs to a duct that, for a variety of reasons, require this repair technique. A partially filled duct due to a malfunctioning pump, or blockage; or a crushed or lost vent tube can delay completion of tendon. Much time can be lost if repairs are not accomplished in a timely manner. Parts for a vacuum grouting system can be secured from numerous national and local vendors and a rugged system can be assembled within a day at a very reasonable price. It is imperative the grouting technician and inspector understand the basic fundamentals of how and why vacuum grouting works. Vacuum grouting is not a cure-all for poor workmanship or design, but in the hand

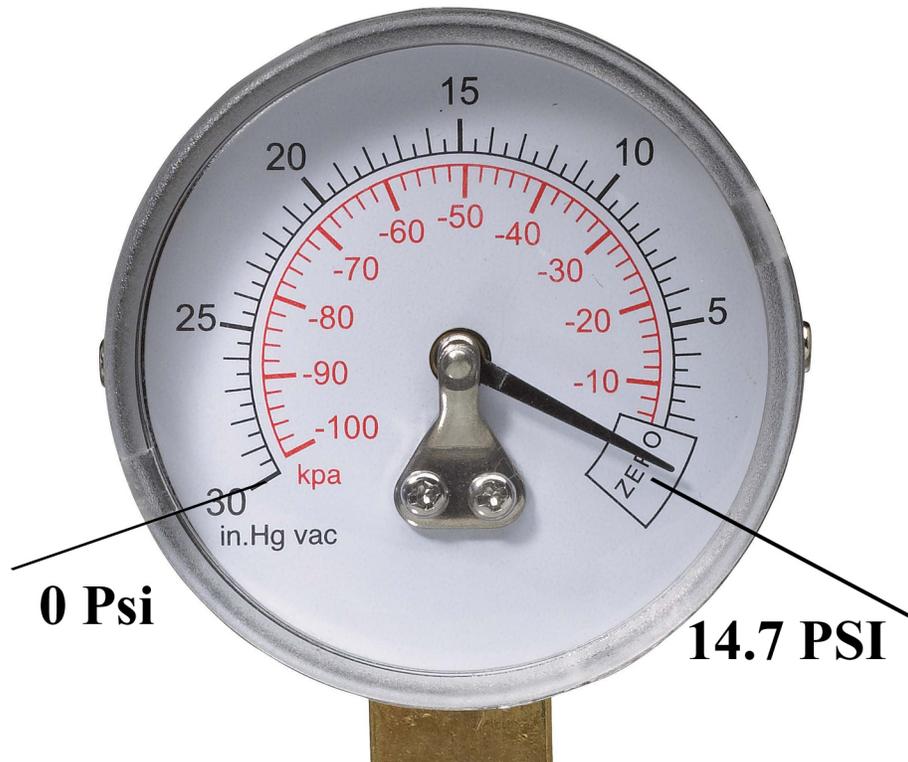
**Fig. 1 Rethink the way you visualize a vacuum gauge**

Attach a vacuum hose, or draw air out of a water bottle with your mouth. It collapses. What has happened is that you have withdrawn the air from inside the bottle, reducing its internal pressure. External air pressure collapses it. Vacuum does nothing- there is nothing it can do. Visualize a vacuum gauge as reading 14.7psi at the 0” pin and 0 psi at the 30” mark (See Fig.1). This is the reality of vacuum. Vacuum is nothingness.

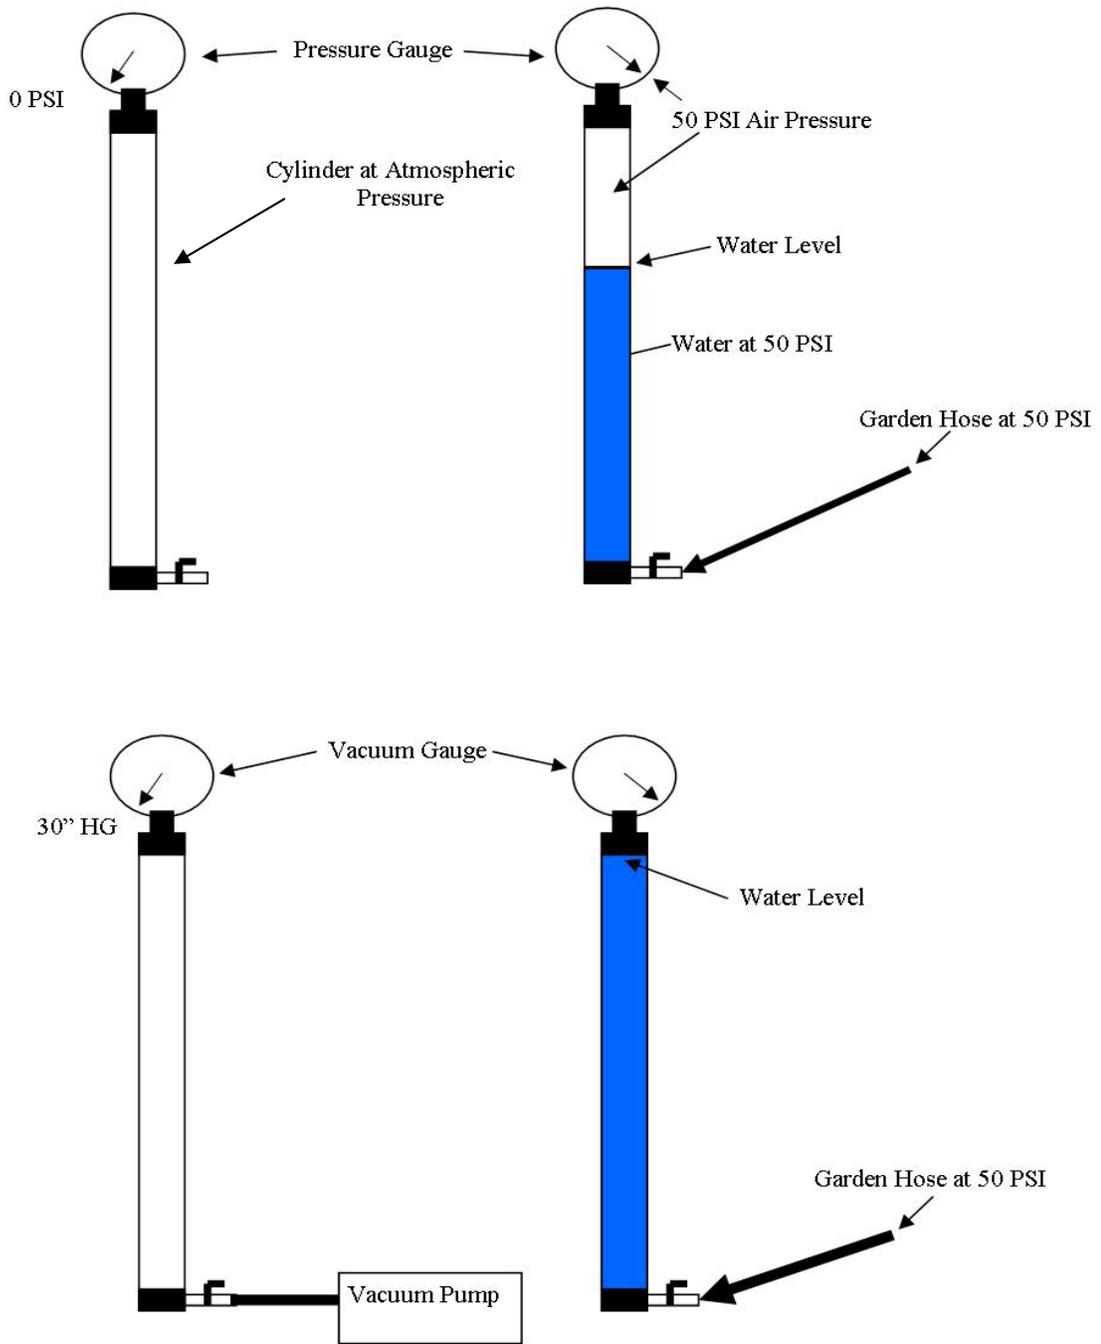
**Fig 2 Proof is in this test- 10 foot clear PVC Tube is used to demonstrate the need to evacuate air to fill a void.**

Demonstrated in the field and represented in the drawings (Fig 2) below is how vacuum grouting works.

In a clear 10 foot PVC pipe, sealed top and bottom, aligned vertically, water at hose bib pressure (50-60 psi, 3.5-4 Bar) is introduced into a valve at the bottom of the pipe. When the air trapped in the tube is compressed by the rising water column to the water pressure of the hose, equilibrium is reached. No more water will enter the tube. We have a partially filled void. Remember the pump-up bottle rockets we used as kids in the Fifties and Sixties? Remove the hose and open the valve- that air pressure is going to shoot the water out.

Evacuate the ten foot PVC, close the valve, and reattach the garden hose. Allow water to fill the pipe. It will fill the pipe virtually 100%. There is no trapped air to reach equilibrium. The minor amount of air trapped at the top is explained. Air is entrapped in the water (it can be seen bubbling out) and absolute vacuum cannot be achieved. The pipe is filled nearly 99.99%. This is the basic principle of vacuum grouting.

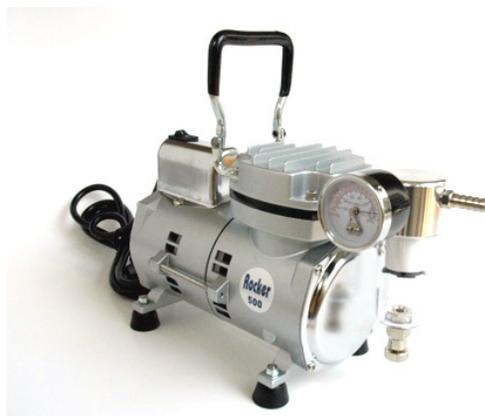
Fig 3. Diaphragm Vacuum Pump

The equipment used for vacuum grouting has improved significantly over the past 7 or 8 years. Initially, some companies used low capacity (low free cfm) diaphragm vacuums (Fig 3). Extremely high, laboratory level vacuum (to the 5 micron) is achieved in the lab, but these pumps are not productive on the job site nor are capable of reducing vacuum to laboratory levels in the field. This author introduced the use of high capacity, refrigeration grade vacuum pumps (Fig 4). High free cfm capacity and exceptionally high vacuum levels (25 micron) could be achieved quickly. This increased job site performance without sacrifice to quality. Adding protective filters and traps to the pump inlet protect the pump mechanism from debris and grit (Fig 6)

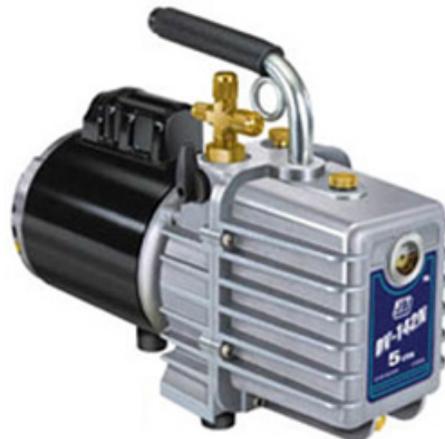
Fig 4. High Capacity Rotary HVAC Vacuum Pump

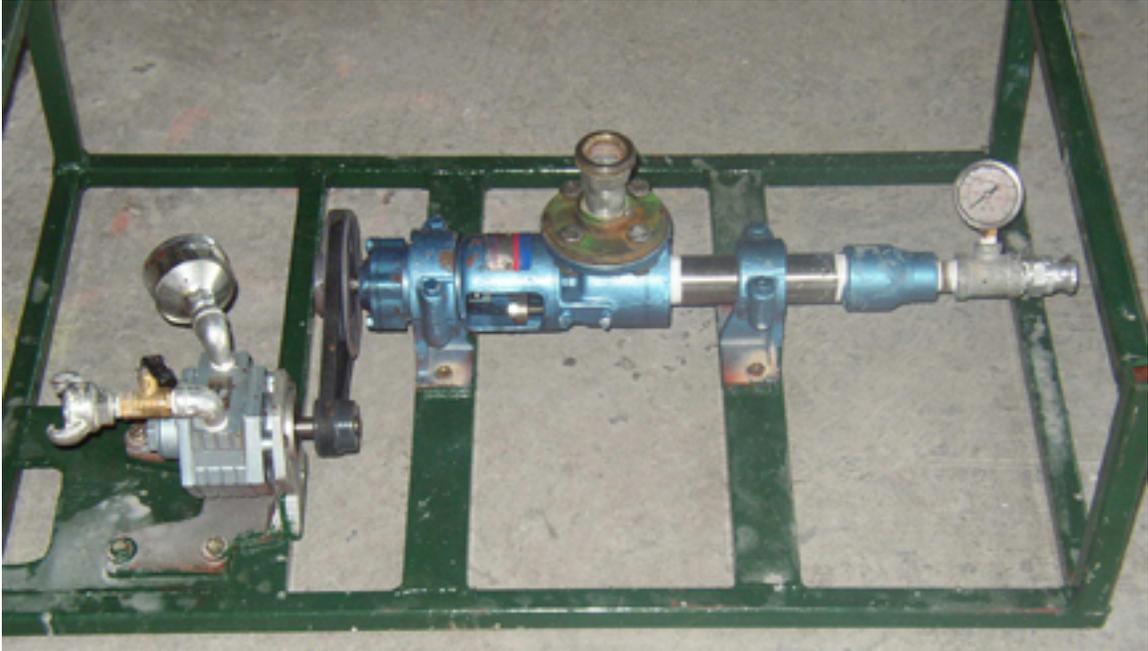
**Fig 5 'Baby' Moyno- progressive cavity pump for vacuum grouting repairs**

Working inside a bridge box culvert, or on the side of a parking structure, requires small mobile equipment. Grouters by nature are a creative bunch. Miniature pumping systems, using compressed air or electricity seem to be a favorite. Commercially available are hand-powered piston pumps, and very small progressive cavity pumps, “baby” Moynos (Fig 5).

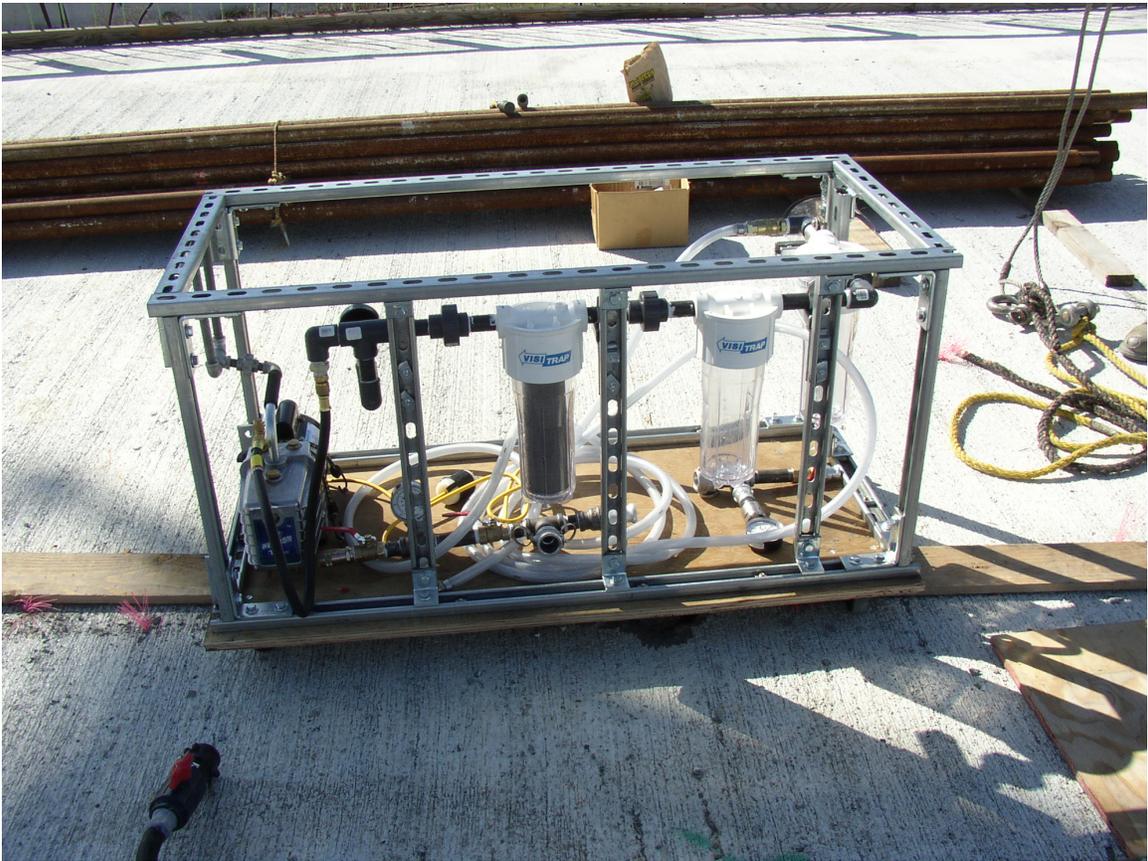
**Fig 6 Vacuum pump and protective filters- Benicia-Martinez Bridge, CA**

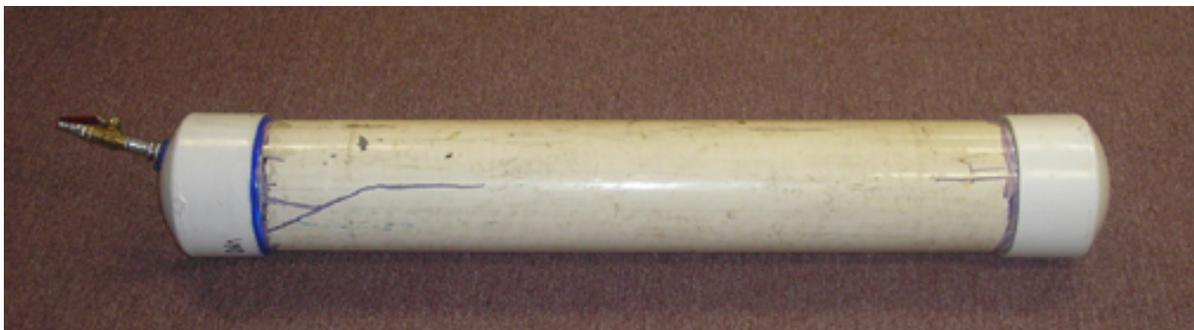
**Fig 7 21.7 Liter Calibration Cylinder for Void Measuring Equipment (VME)**

A test cylinder (Fig 7) should be on site, either provided by the state DOT, engineer or contractor to demonstrate the accuracy of the void measuring equipment. Repeatability, the quality that results measured will be consistent, is of primary importance.

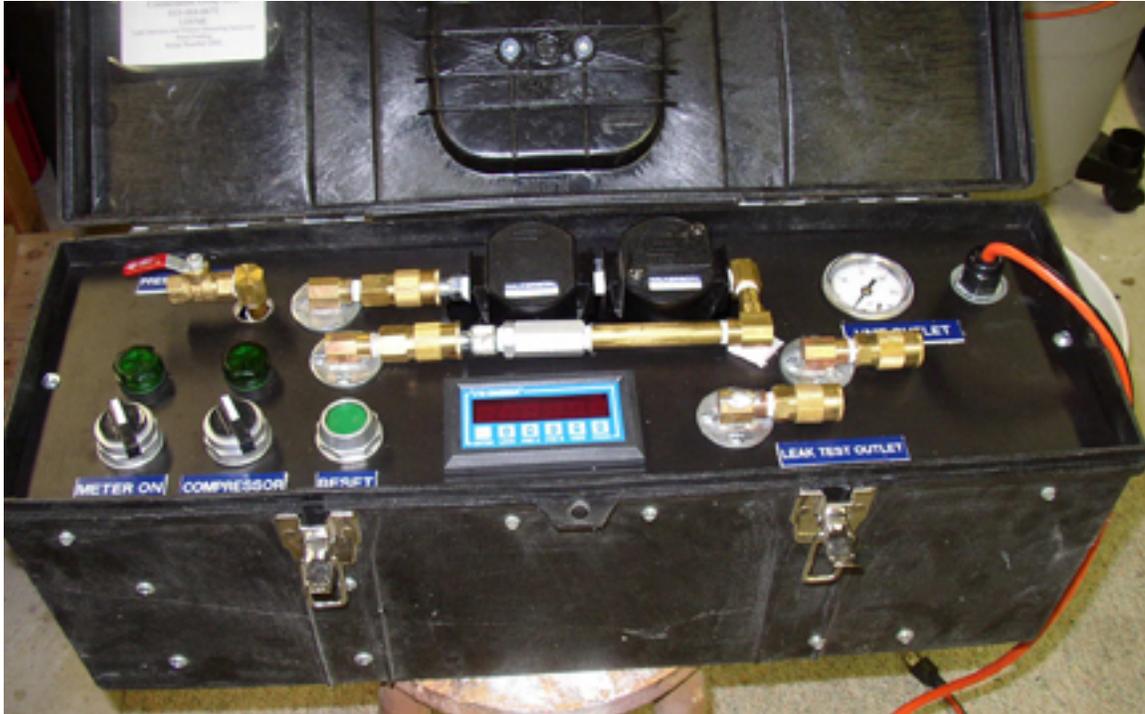
Fig 8. Forensic Void Measuring Equipment- contains system for pressurizing and detecting leaks

The answer is to measure the void. Early void measurement equipment used analog natural gas meters. The void was evacuated and air is allowed to rush back, and the air volume measured. There were variations on this methodology. This equipment was bulky, heavy, slow, and not as accurate as newer electronic equipment (Fig 8). However, the limitations of both types of systems are discussed below.

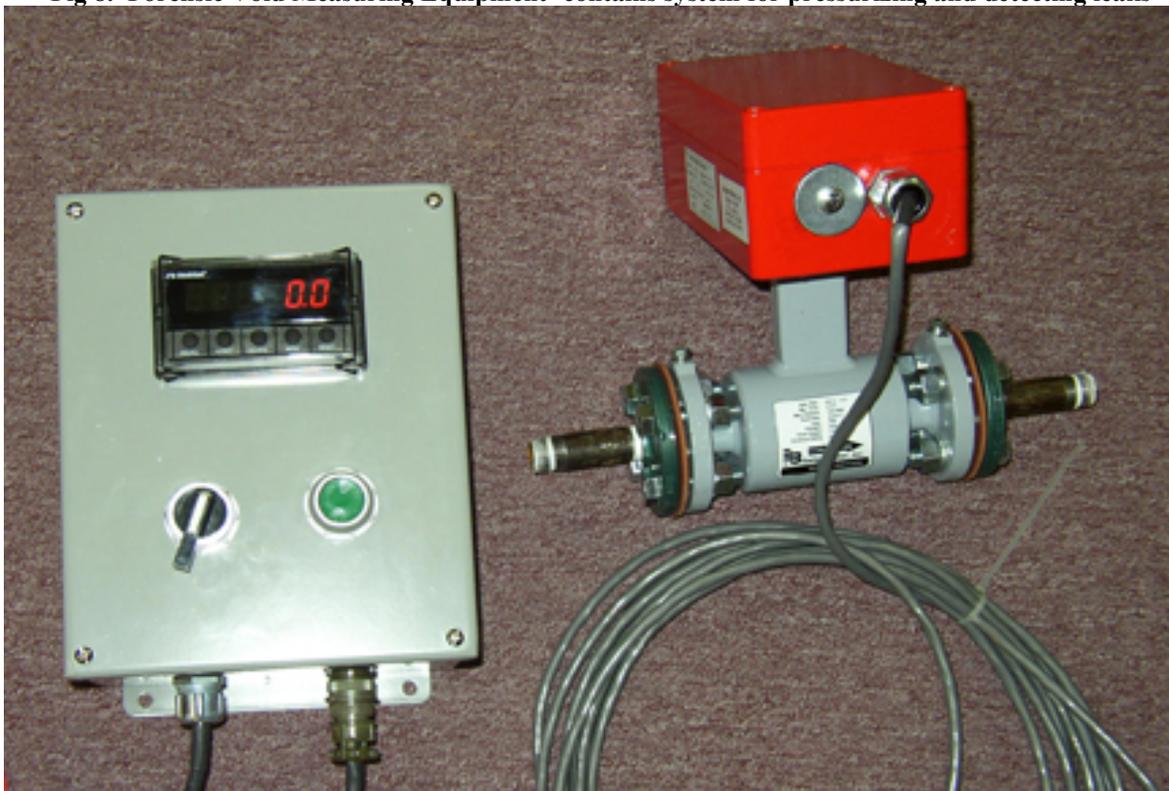
Fig 9. Grout Flow Meter- measures in liters or other standard units

Once the void size is determined, grout can be measured as it is pumped into the void. This can be done by measuring the volume drop in the grout tank, or using an electronic grout flow meter (Fig 9).

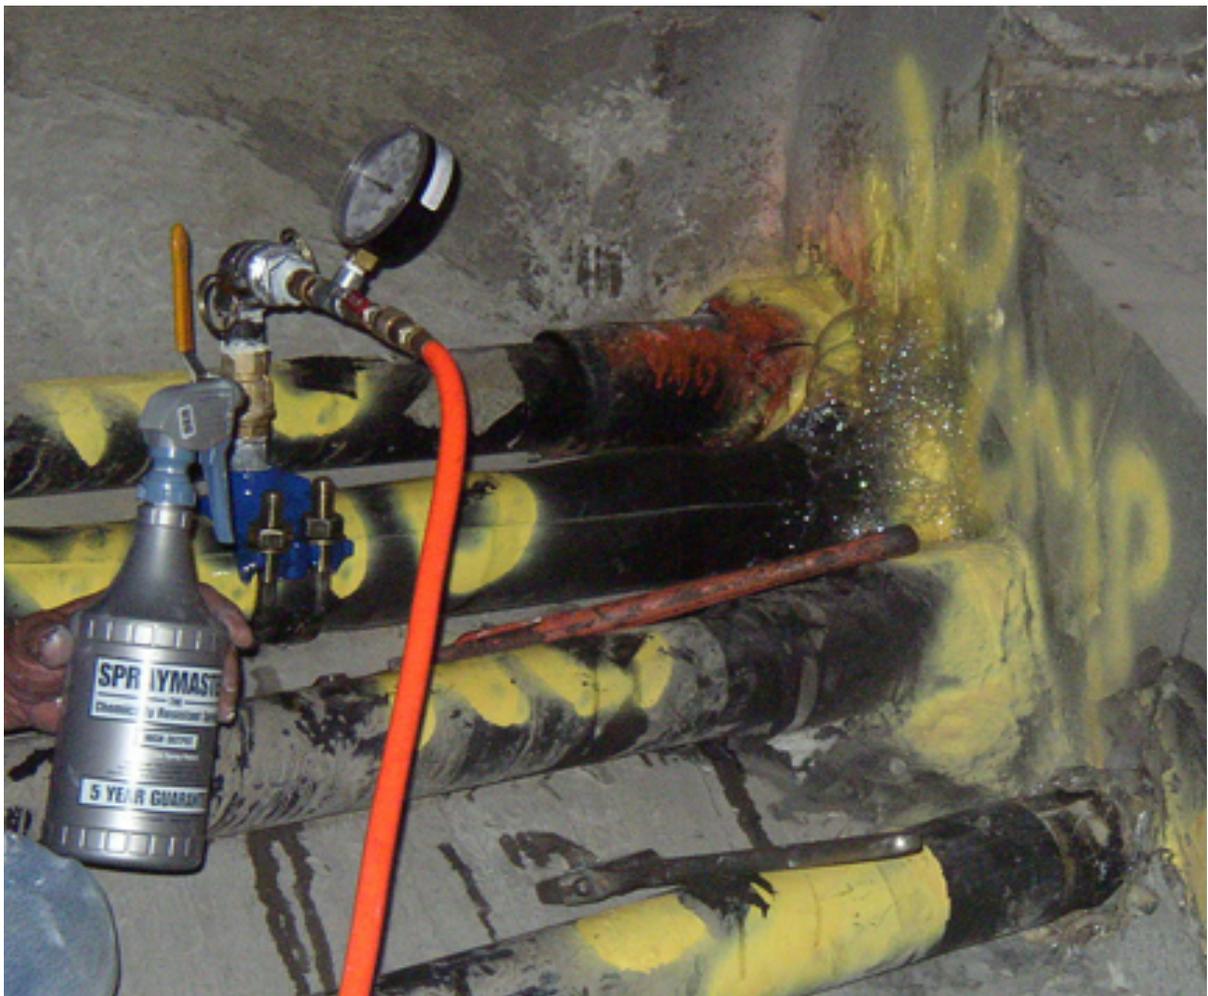
**Fig 10. Pressurized Duct with Soapy Water Identifying a Leak- Sunshine Skyway Bridge, Tampa, FL**

Chasing and repairing leaks is time consuming. The methodology, however, has stood the test of time. A mixture of liquid soap and water in a spray bottle, along with compressed air into the void is perhaps the simplest and most effective method of leak detection (Fig 10). Knowledge of the post-tension duct system, internal or external, helps in predicting the likely locations for air leaks. Once the air leaks are fixed, vacuum grouting can commence.

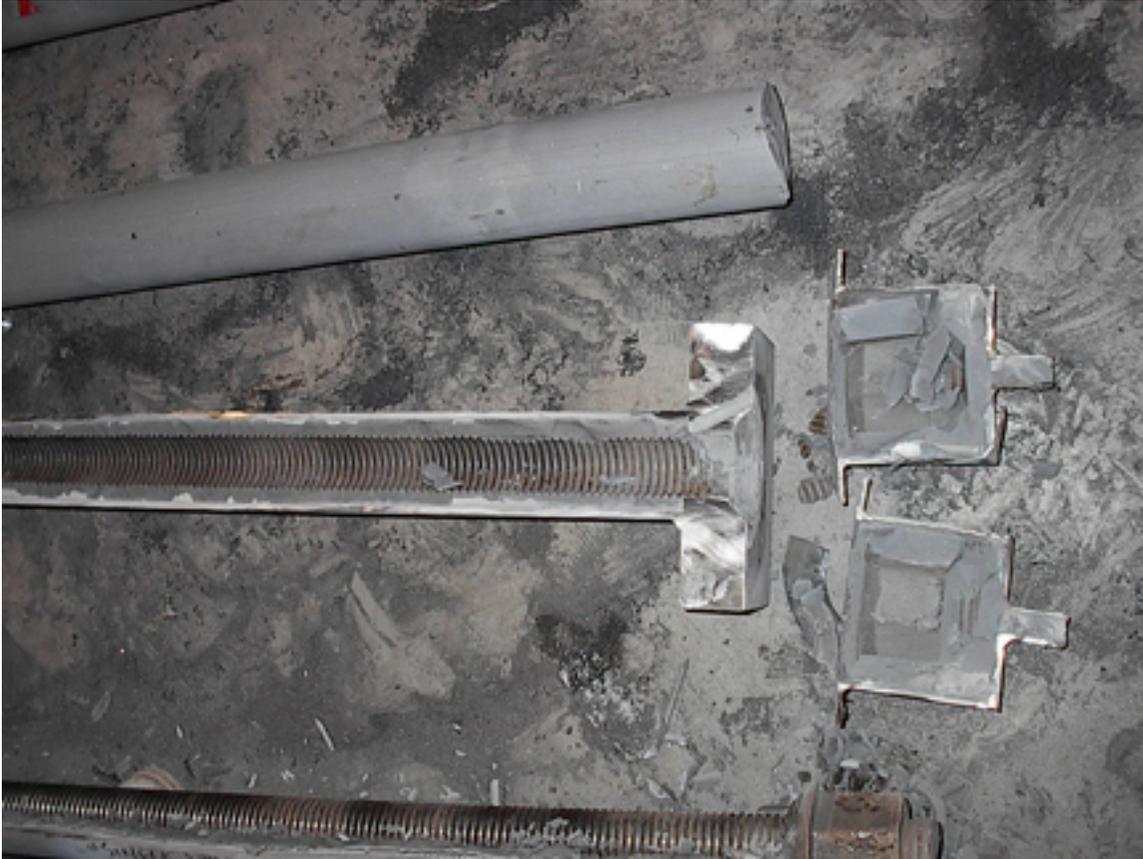
**Fig 11. Cutaway of Sunshine Skyway test sample, loop tendon repair**

This method of grouting utilizes the advantage of a vacuum pump located at the far end of a tendon. Grout is introduced at one end while vacuum is drawn from the other. The net improvement of grout pumping pressure is 14.7 psi. The advantage is that air is removed from possible high points in the duct and from the interstitial spaces of the strand. A high capacity vacuum pump should be used to keep the vacuum high as the grout is advancing. A trap is necessary to prevent grout from entering the vacuum pump (Fig 6). Vacuum assisted grouting was used at the first Sunshine Skyway Repair project. The damaged loops tendons were replaced with conventional mass concrete/rebar below the water table, and stressed bar in the upper sections. The last 10 feet of the stressed bar used vacuum-assisted grouting to ensure complete encapsulation of the bar (Fig 11).
