From a Deep Hole to Success

Austin, Texas, Grouting Project Tackles Challenges

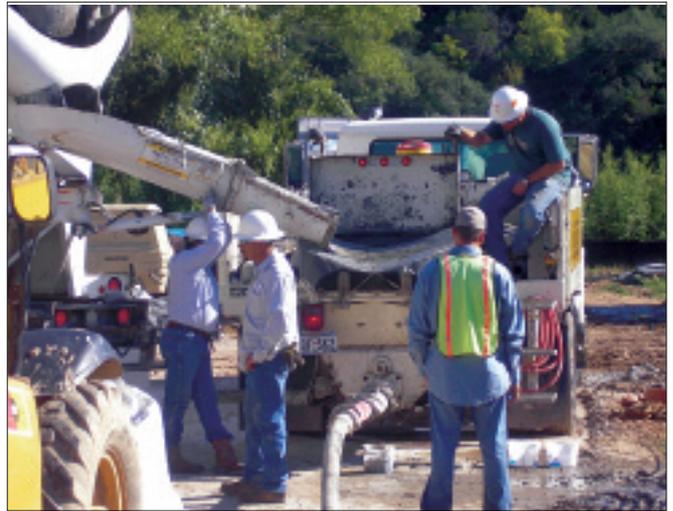
Constellation Group has performed grouting work using HDD technology, expanding the capabilities of the pipeliner to reach areas previously unavailable.
